TECHNICAL REPORT NO. 6-570

DURABILITY AND BEHAVIOR OF PRESTRESSED CONCRETE BEAMS

LABORATORY TESTS OF WEATHERED PRETENSIONED BEAMS

October 1971

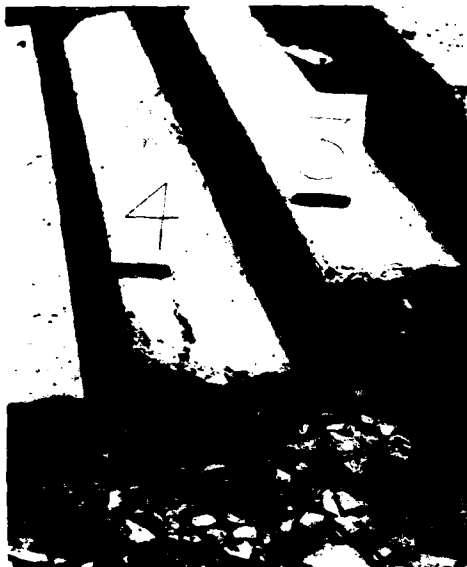
a. Beam 4, landward end

7. Photograph 1*a* and *b* shows beam 4 on the beach at Treat Island, as viewed from its landward and seaward ends, respectively, while it was under exposure. The protective epoxy pads had come off of both ends of the beam and there was considerable spalling (photograph 2*a* and *b*).

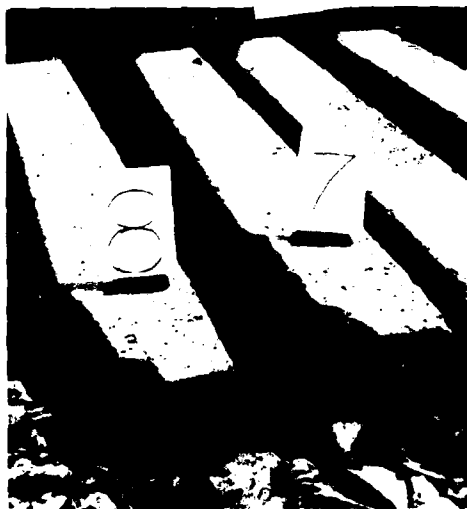
c. Beam 8, landward end

8. Photograph 1*c* and *d* gives the landward and seaward views of beam 8 under exposure. (Beam 8 is on the left in photograph 1*c* and on the right in photograph 1*d*.) The protective epoxy pads had come off of both ends and there was considerable spalling, especially on the landward end (photograph 2*c* and *d*).

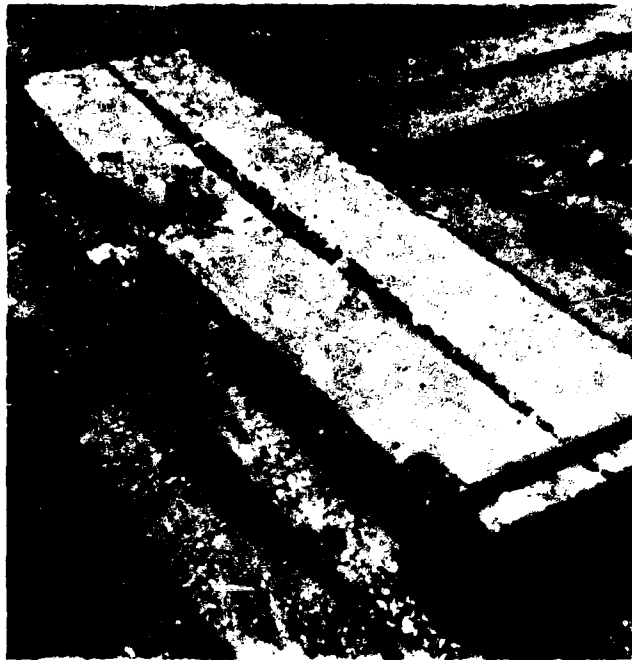
a. Beams 10 and 18 with yoke after failure of beam 18 (on left)
